HXS Off-Line Tests at LLE

John Seely, Glenn Holland, and Rob Atkin

November 13-17, 2000

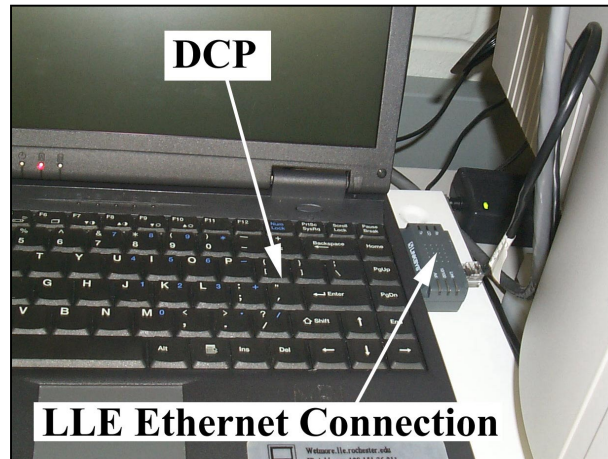
Fig. 11. The LLE Ethernet connection to the DCP in La Cave.

On Thursday, November 16, the DCP was connected to the LLE Ethernet as shown in Fig. 11. After making software modifications, the LLE OIP command sequence was implemented, and good CCD images were acquired in an automated manner.
